**RE: Clean Harbors Wichita, LLC Part B
Tank Certification Statements**

Clean Harbors Wichita, KS facility Tank V-1 Hazardous Waste Storage

Conduct and internal and external visual and ultrasonic thickness evaluation of the inspection of Tank V-1 in accordance with the API 653 Code regulations and guidelines.

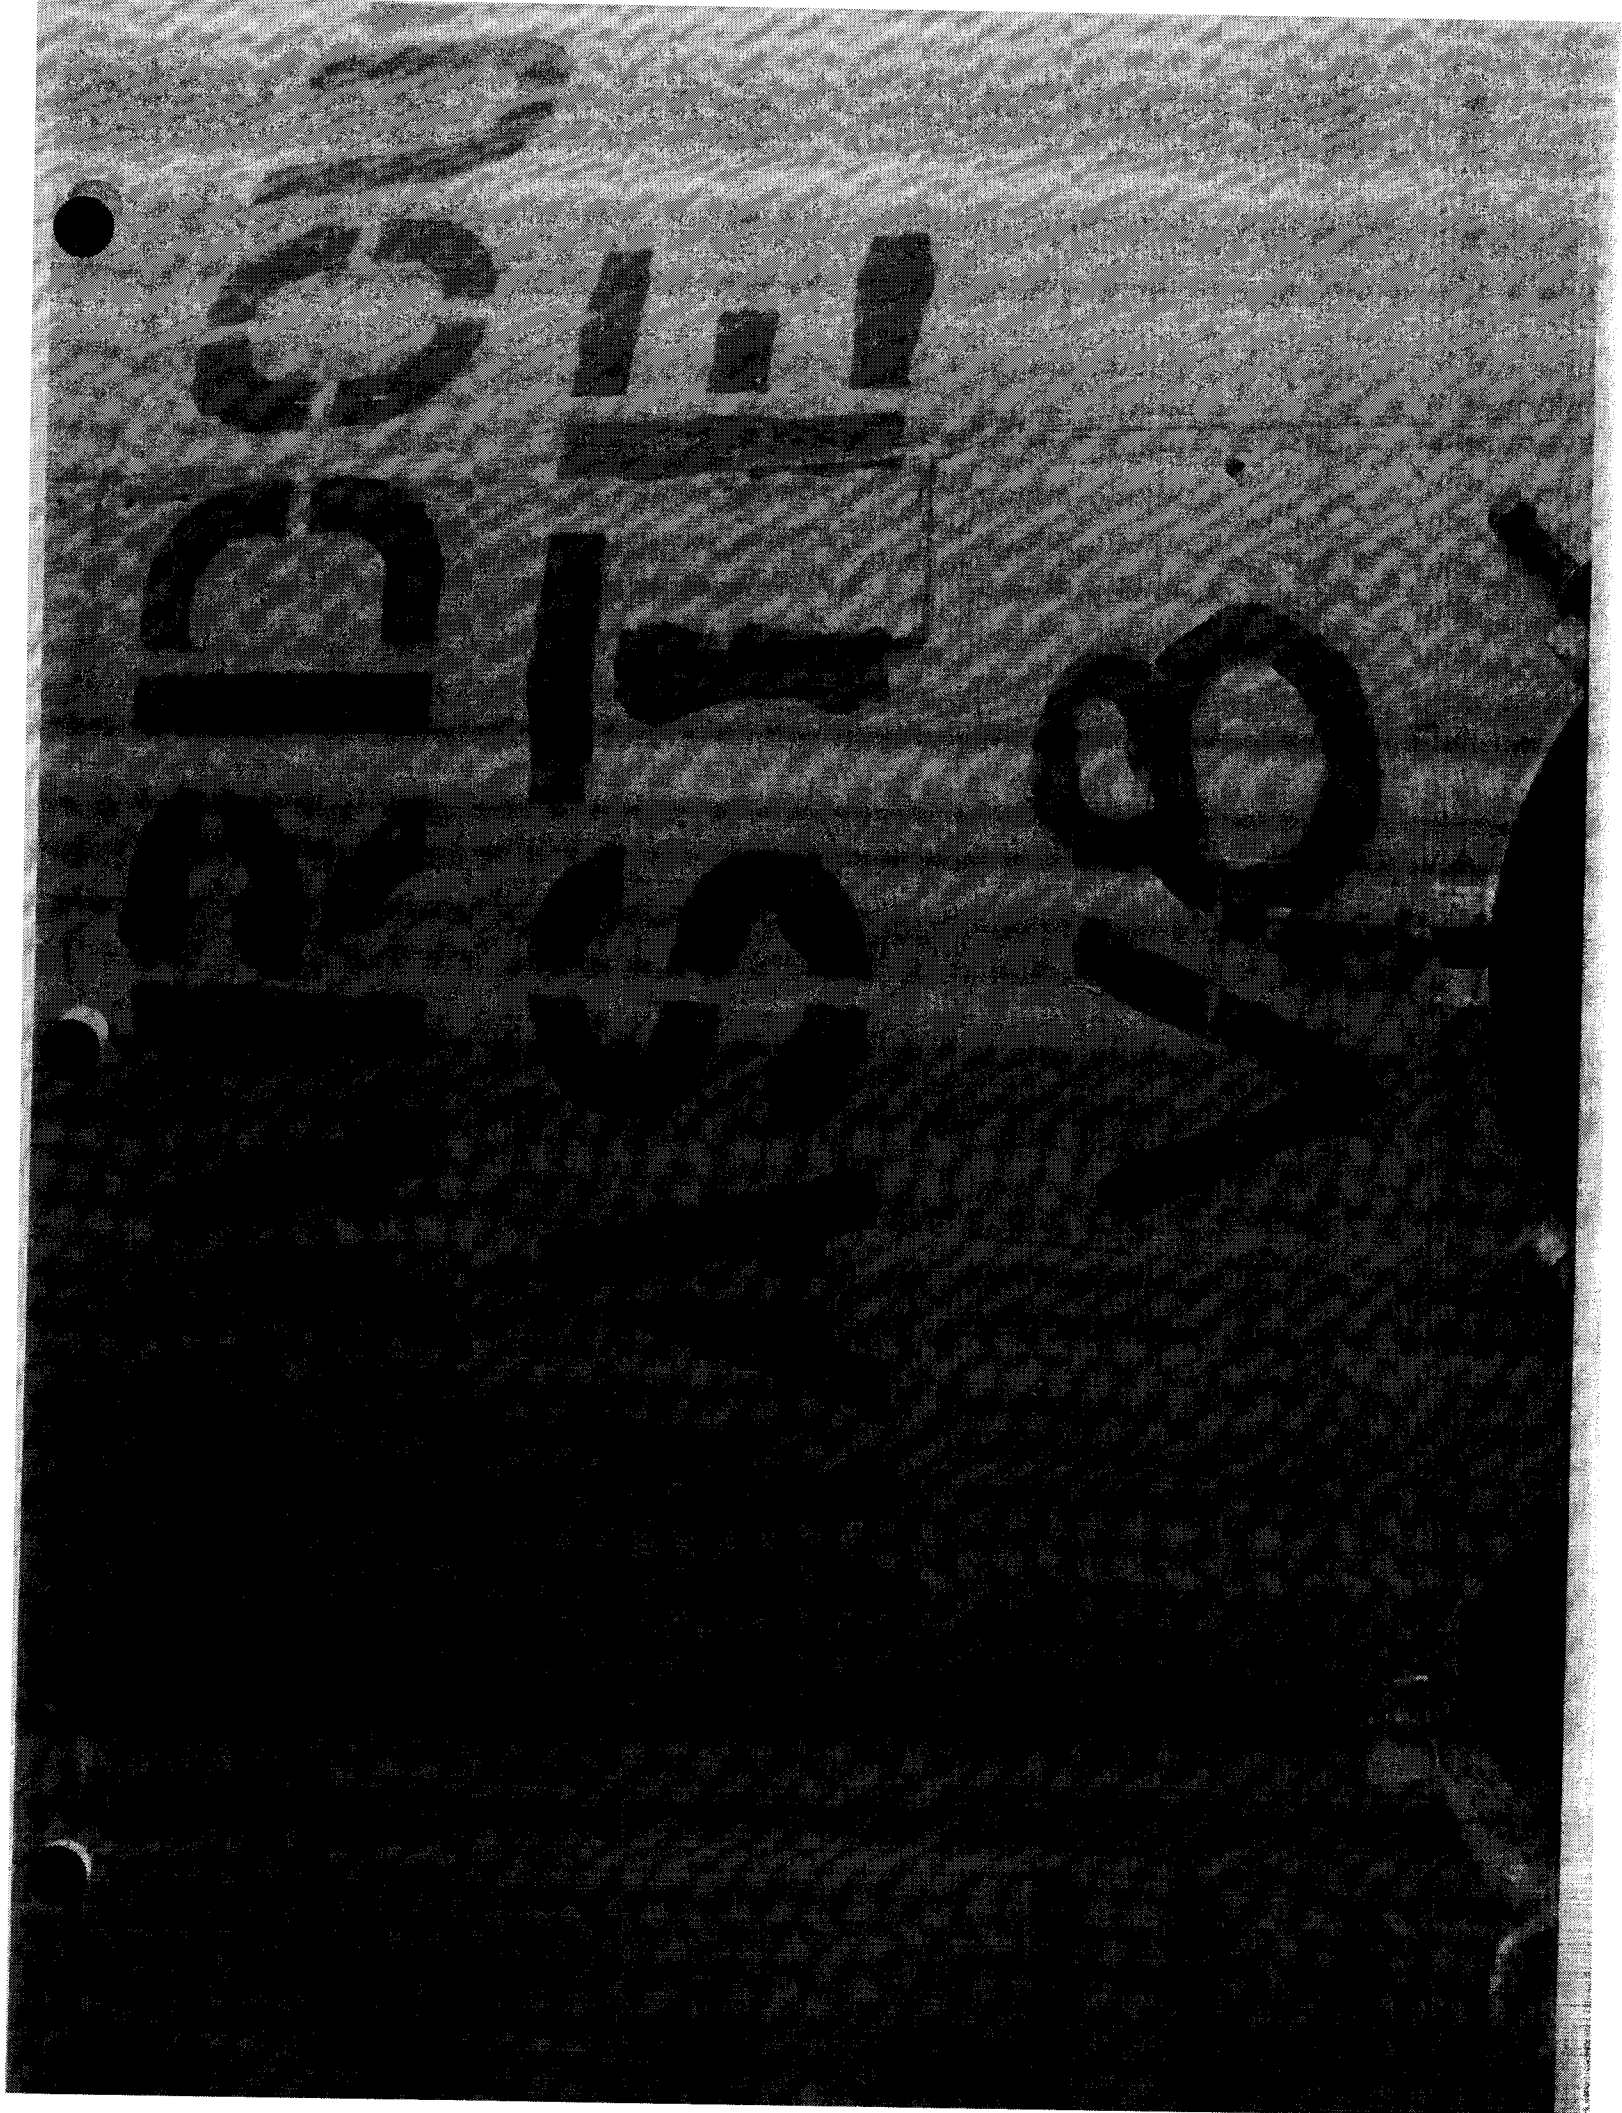
corrosion on
inside of hatch
lid

Replace gasket on to inspection hatch.

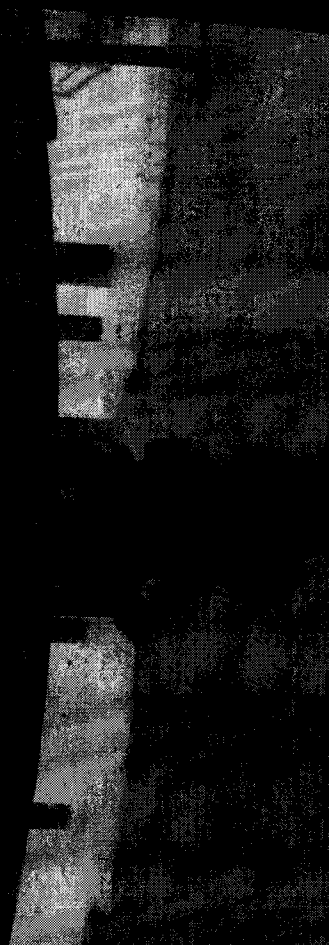
Coating has several coating failures. There are small blisters under the coating that have corrosion attacking the shell. No signs of leakage around nozzles.

several paint
blisters with
severe
corrosion
under blister

dent

Complete coating repairs.
